UNITED STATES PUBLIC LAND SURVEY CORNER CERTIFICATE OF

Land Survey Monuments situated in Section 7, Township 87 North, Range 14 West, of the Fifth Principal Meridian, Black Hawk County, Iowa, Previously recorded in Not Applicable in County Recorder's Office

NW Cor.

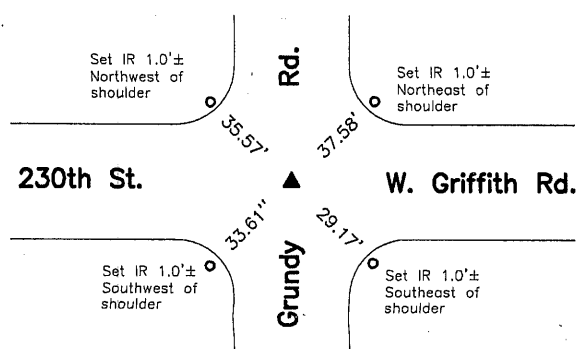
Grundy County Engineer's Record Ties

Corner Recovery =
Searched 5.0'Ø area around the intersection point of the apparent centerlines of gravel roads North-South and East-West with metal detector, excavated 1.0'Ø x 1.7' deep hole and found 1/2"Ø x 0.8' orange capped iron rerod (#6505), 0.8' deep leaning East. Tied out rerod, removed it and found 4" x 4" brass capped concrete monument stamped '1', '6', '7', and '12', 1.6' deep. Concrete monument is in apparent centerline of traveled surface of gravel roads East-West and North-South. Monuments found matches that of record, but rerod appears to have been disturbed. Therefore, reset rerod (plumb), 0.8' deep on center of brass cap to raise up monumentation and used it as the correct corner. All ties are plumb distance unless indicated otherwise.
