Lee O. Gallentine PLS, Ryken Engineering, 711 Park Avenue, Ackley, Iowa 50601 - Ph. 641-847-3273 - Fax 641-847-2303

UNITED STATES PUBLIC LAND SURVEY CORNER CERTIFICATE

Land Survey Monuments situated in Section 8 , Township 87 North. West, of the Fifth Principal Meridian, Black Hawk County, Iowa, 13

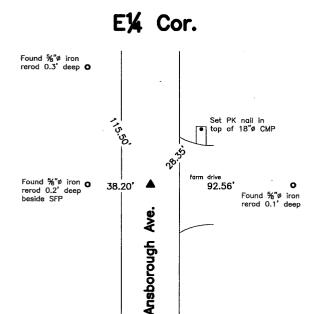
E¼ Cor. - Partial History of Corner =

Monument Description, Remarks, and Plan View:

1910, May 6 - Co. Aud's Surveyors Record Bk 1 Pg 18 indicates corner was found.

2008, Mar. 5 - 'FND %" ALUM CAPPED IRON REROD' by Lee O. Gallentine per Co. Rec's Doc. No. 2008019295. 2011, Jun. 10 - 'FOUND %" REBAR' by David L. Scheil per Co. Rec's File 2011-00023680.

Searched area with metal detector, excavated 1'ø x 0.7' deep hole and found concrete monument (broken) 0.6' deep with 1/8" × 2.8' iron rerod 0.6' deep on north side (for locating purposes only) at 1'± West of apparent centerline of traveled surface of gravel road North—South. Location of monument found matches that of record, monument found matches that of record, and record ties are within reason. Therefore, set 'Survey Mark' in center of concrete monument to perpetuate monumentation, drove rerod to 0.9' deep for locating purposes only, and used nail as the correct corner. All ties are plumb distance unless indicated otherwise.
